## PROJECT PROFILE

**PROJECT:** Separator Rebuild  
**LOCATION:** United Kingdom

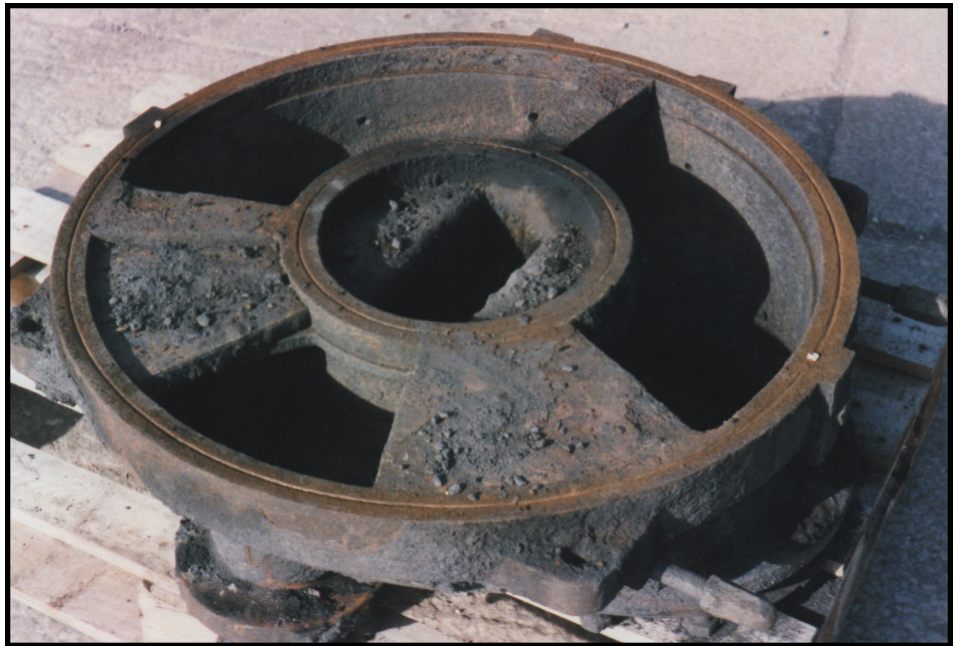
This photograph shows part of the coal separation unit in a coal preparation plant.

After continual use over an extended period of time this piece of equipment had eroded and corroded badly due to the high levels of abrasion it was subjected to.
