PROJECT PROFILE

PROJECT: Farmhouse - External Refurbishment
LOCATION: United Kingdom

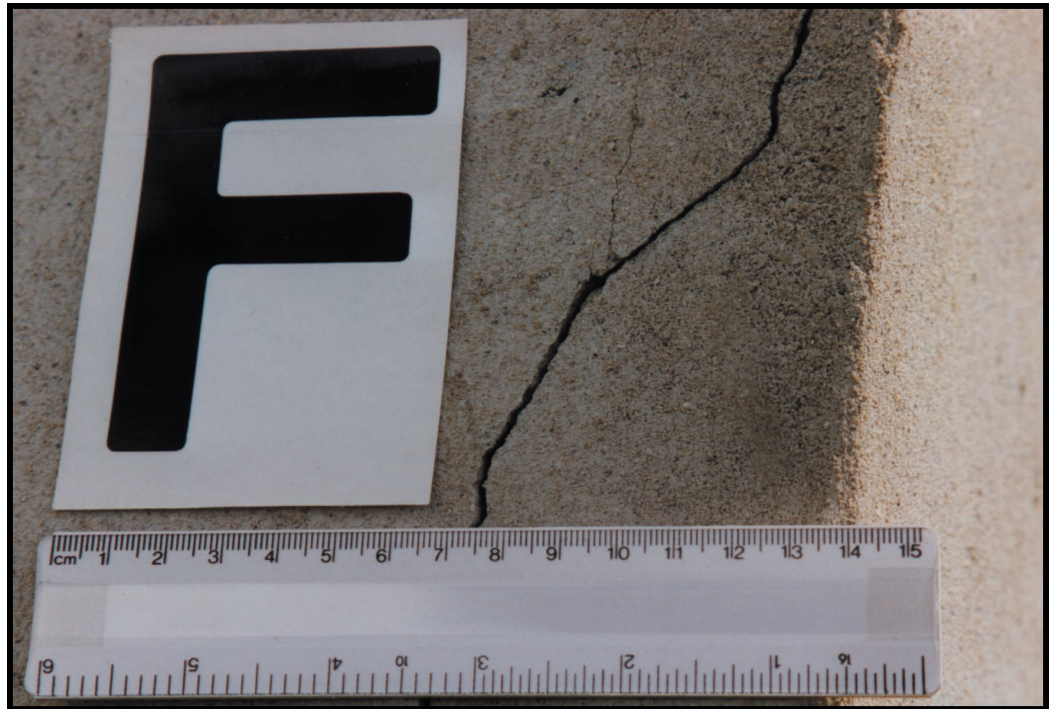
The external rendering on this 19th century farmhouse had been replaced, but had suffered shrinkage and cracking as the newly applied render cured.

Conventional masonry coatings would not allow for this shrinkage and movement.
