PROJECT PROFILE

PROJECT: External Walls - Church
LOCATION: United Kingdom

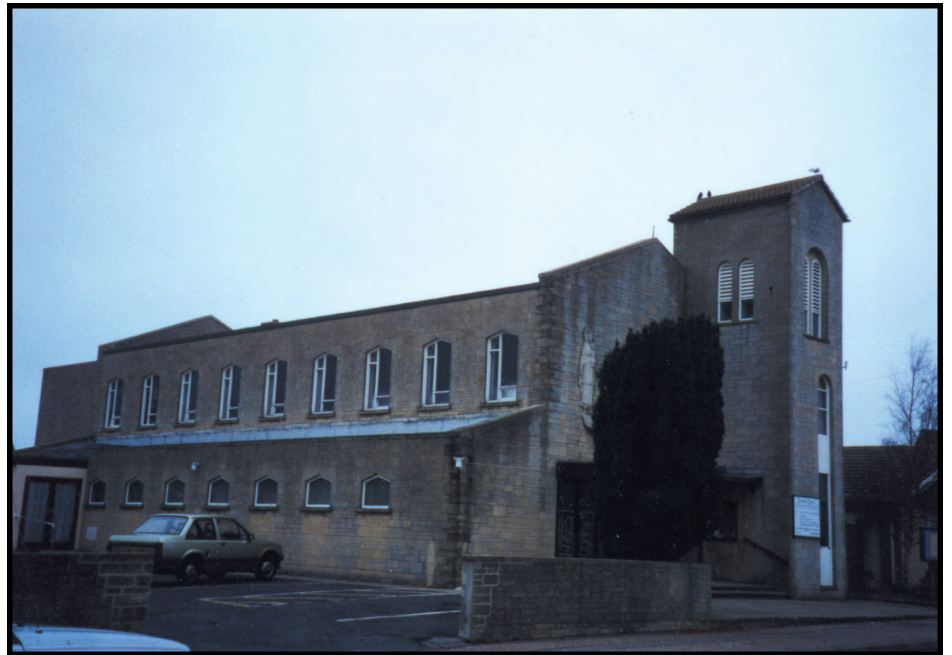
The external walls of this church were starting to deteriorate.

The stonework had discoloured badly and erosion and carbonisation was starting to occur.
