## PROJECT PROFILE

**PROJECT:** Textile Manufacturer - Concrete Tank Refurbishment  
**LOCATION:** Romania

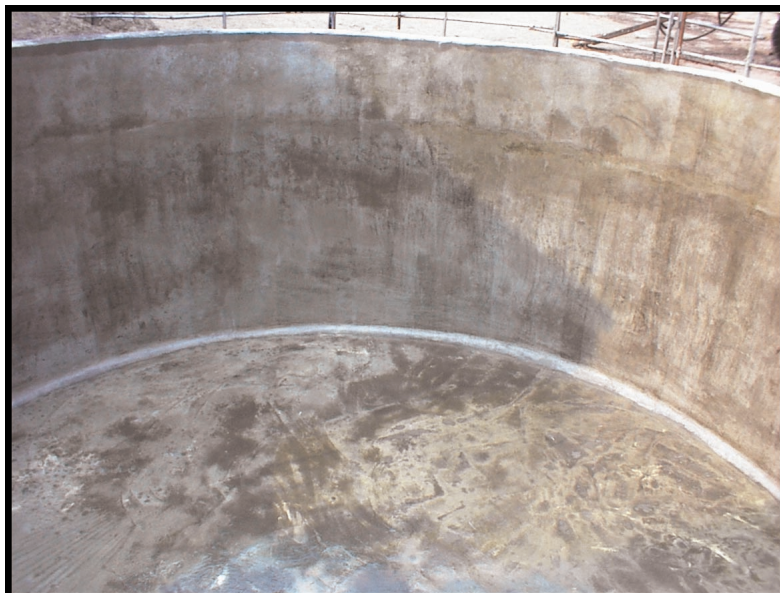
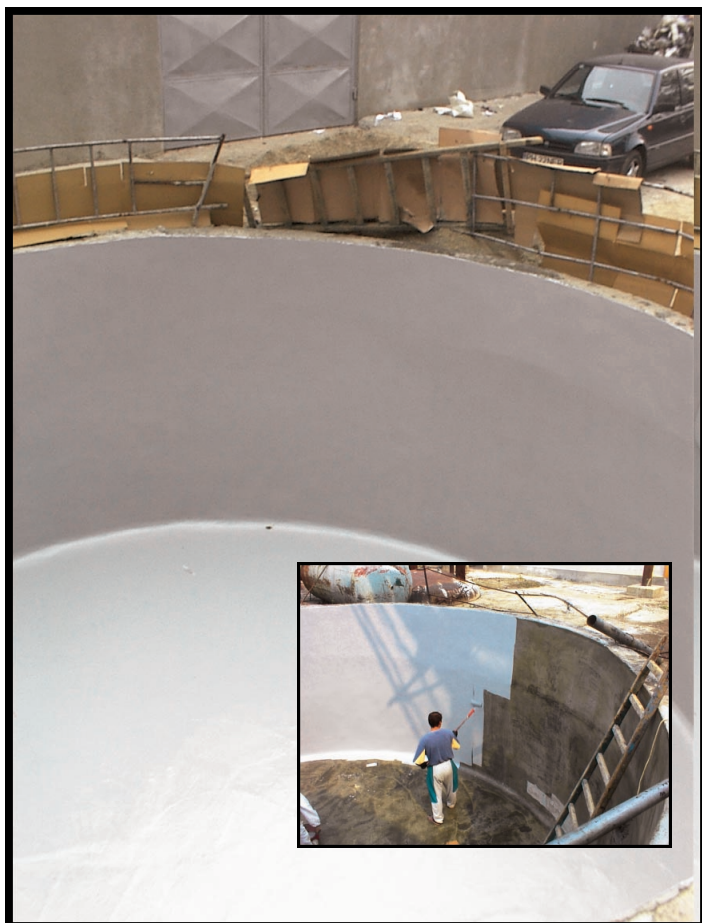
The concrete tank in this photograph normally contains a salt solution used in wool processing. The concrete had begun to degrade.

The concrete was repaired by conventional means and suitably prepared prior to the application of Floor-Tech SFU. Two coats of our two component, solvent-free polyurethane coating Chemi-Tech PU were then applied to the primed surface.
