PROJECT PROFILE

PROJECT: Handrail Refurbishment
LOCATION: Singapore

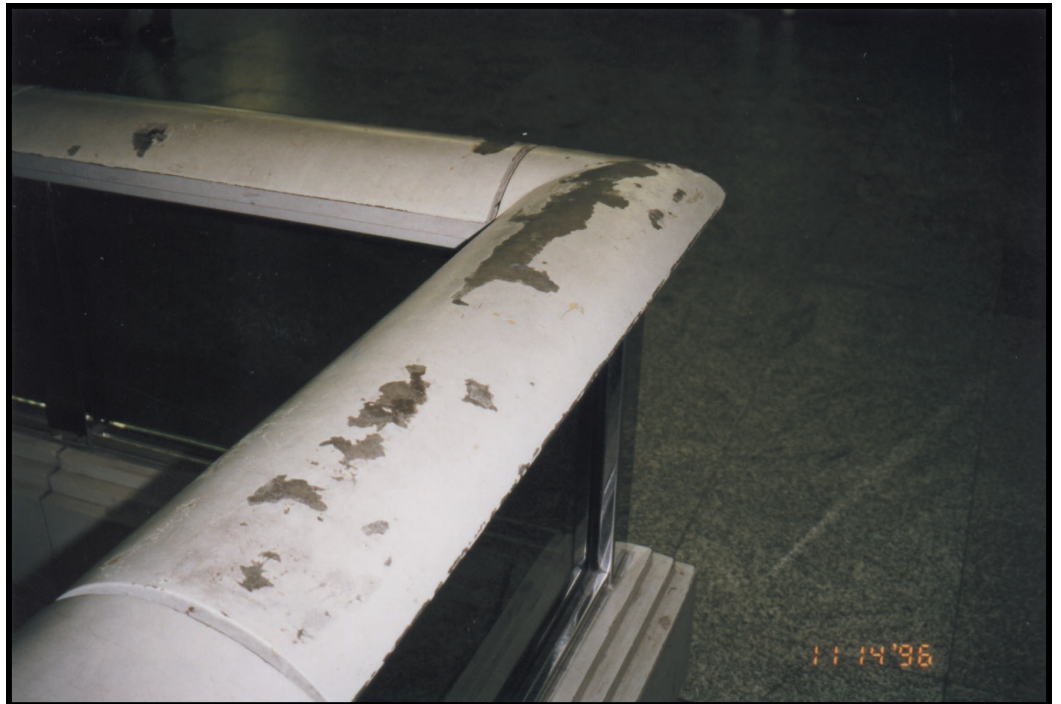
The balustrading and hand rails within the Somerset MRT Station in Singapore were in poor condition with loose paint and paint failure causing an unsightly appearance throughout the station.
