## PROJECT PROFILE

**PROJECT:** Balcony Protection  
**LOCATION:** Austria

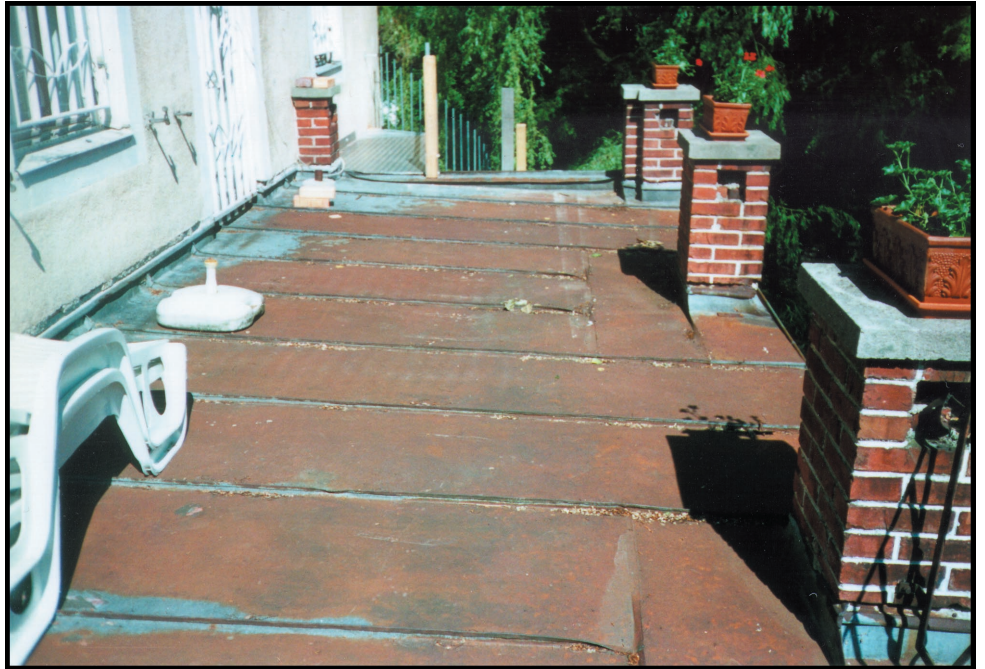
As can be seen from the photograph, the galvanised steel balcony had been suffering from severe rusting as well as leakage through several substantial holes.

The holes were sealed by means of bonding steel plates to the balcony. The heavily rusted areas were then coated with Corro-Tech GP, our high performance anti-corrosive coating. One coat of Uni-Tech MC Primer was then applied to the whole surface. A finish consisting of two coats of Floor-Tech PU was used.
