## PROJECT PROFILE

**PROJECT:** Tug Boat Engine Liners  
**LOCATION:** Brazil

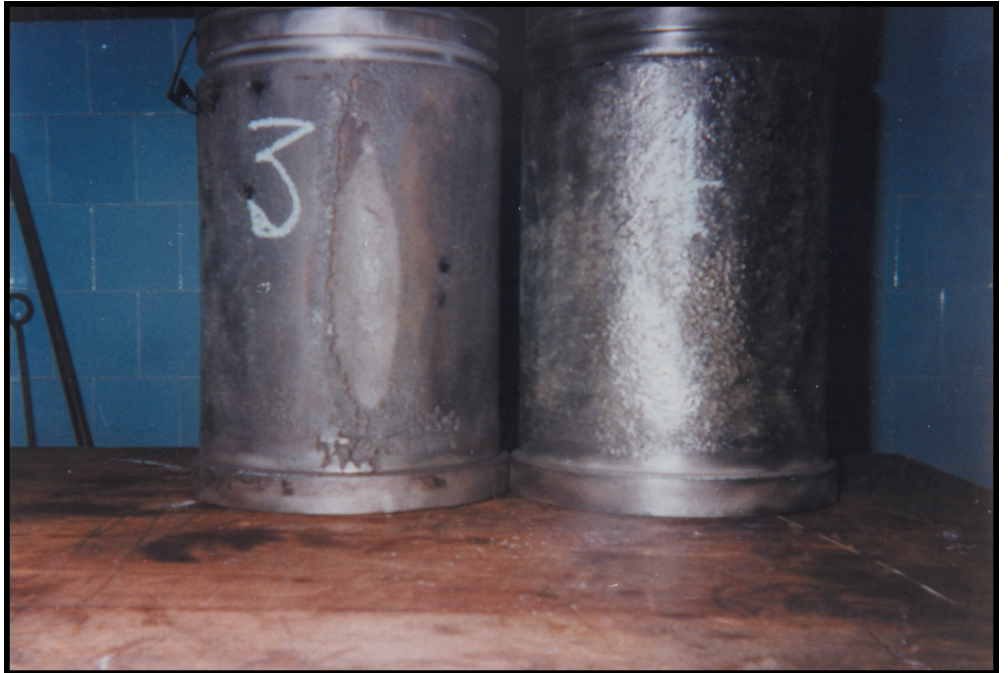
After extensive use, the external areas of engine liners within a tug boat in Brazil had become seriously corroded and eroded and the condition of these liners suggested that they had to be scrapped.

The recommended Thortex solution was to blast clean the liners in question to remove all loose material, rust and surface contamination. This blast cleaning process provided an excellent profile for the application of Metal-Tech EG and Metal-Tech FG. Heavily worn areas were rebuilt with Metal-tech EG and the cured EG was then machined to bring the rebuilt area in line with the surrounding surface. The entire liner was then protected with Metal-Tech FG. As a result of this success, a further 24 liners have been protected.
