## PROJECT PROFILE

**PROJECT:** Distribution Warehouse - External Protection  
**LOCATION:** United Kingdom

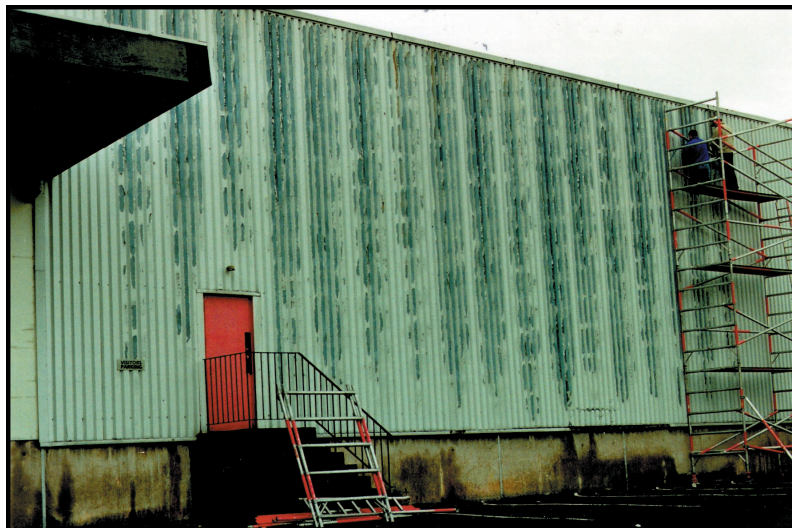
The external structure of this warehouse was plastisol coated metal cladding which was in a poor condition.

Some areas were totally degraded resulting in corrosion; in other areas the plastisol film had degraded and all adherence to the metal lost and in other areas the plastisol still had good adherence to the metal, but had badly discoloured.

The areas which were worst affected and where corrosion had started were first wire brushed and then coated with Corro-Tech GP.

Due to the type of plastisol involved, the entire surface which was 2,500m<sup>2</sup> was then protected with one coat of Uni-Tech MC Primer and one coat of Uni-Tech UV using airless spray equipment.
