PROJECT PROFILE

PROJECT: Hotel Roof Refurbishment
LOCATION: Portugal

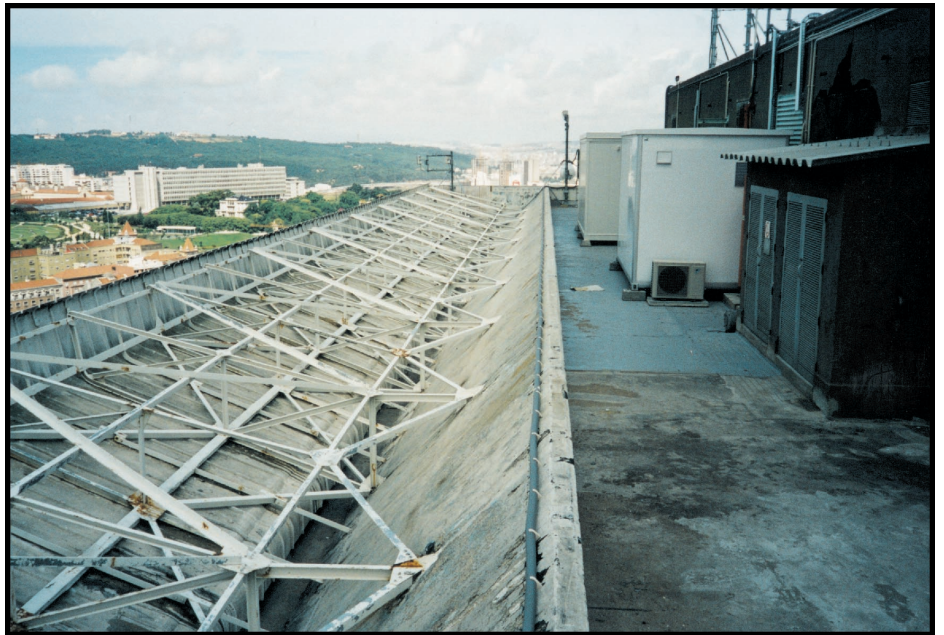
The roof of this Sheraton Hotel had deteriorated over the years and was in need of repair.

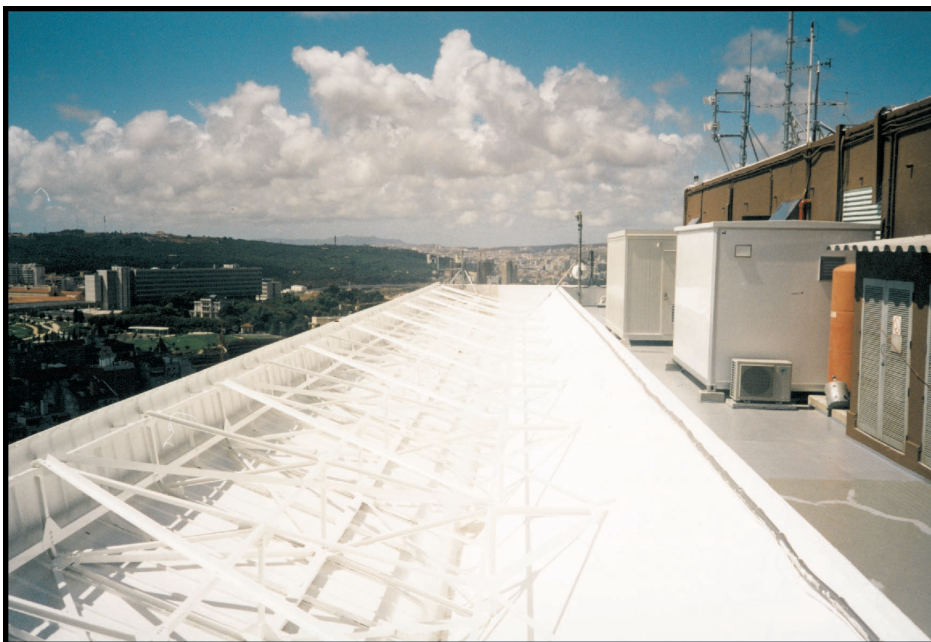
The end result, as seen in the photograph, is testament to the high quality and performance capability of Thortex specialist coatings and repair products.

The main roof area was prepared and primed with Poly-Tech BP Primer prior to the application of two coats of our universal roof protection system Poly-Tech.

The structural steelwork supporting the roof was patch primed with Corro-Tech GP followed by one coat of Uni-Tech GP Primer and then a topcoat of Uni-Tech UV.

The areas of the roof, which are subject to foot traffic, were treated with Floor-Tech FB Primer followed by Floor-Tech FB. A topcoat of Floor-Tech PU was then applied.
