## PROJECT PROFILE

**PROJECT:** Tanker Protection  
**LOCATION:** Austria

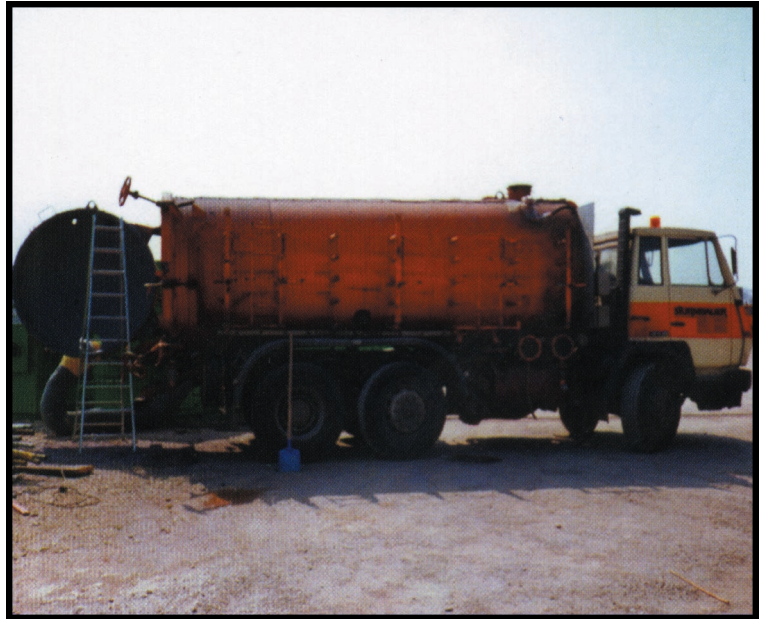
This lorry was used by a chemical company to transport aggressive chemicals and sewage.

The internal surfaces of the storage tank had become badly worn and corroded and required relining with a chemical resistant coating.
