PROJECT PROFILE

PROJECT: External Wall Protection
LOCATION: United Kingdom

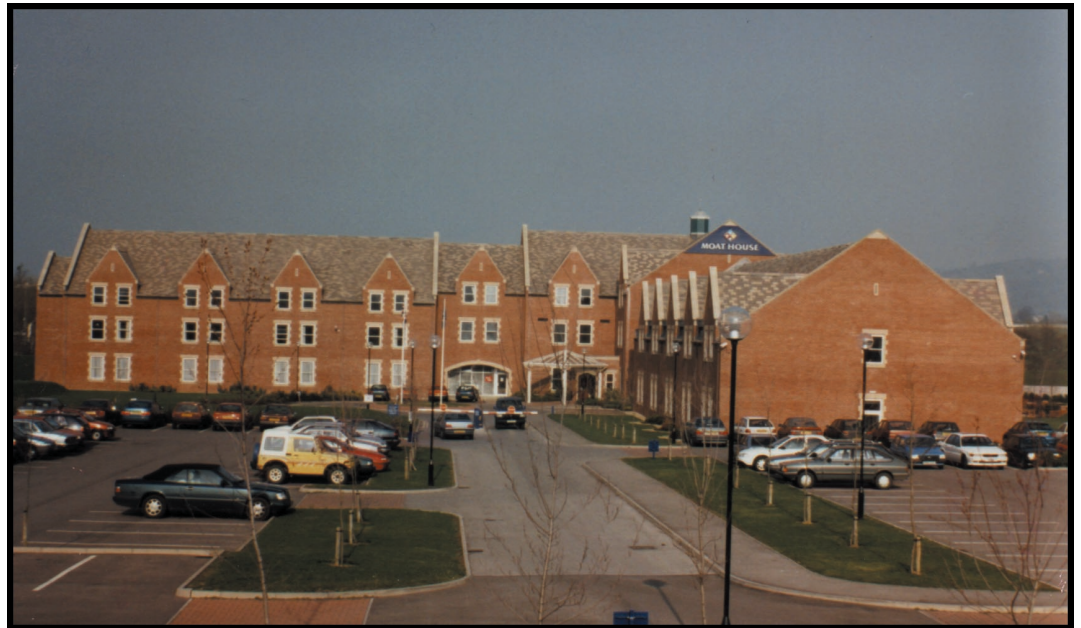
The walls of this hotel were suffering from severe ingress of moisture which was coming through porous brickwork and damaging the finished decor within the building.
