PROJECT PROFILE

PROJECT: Police Station – Floor Refurbishment
LOCATION: Berwick-on-Tweed – United Kingdom

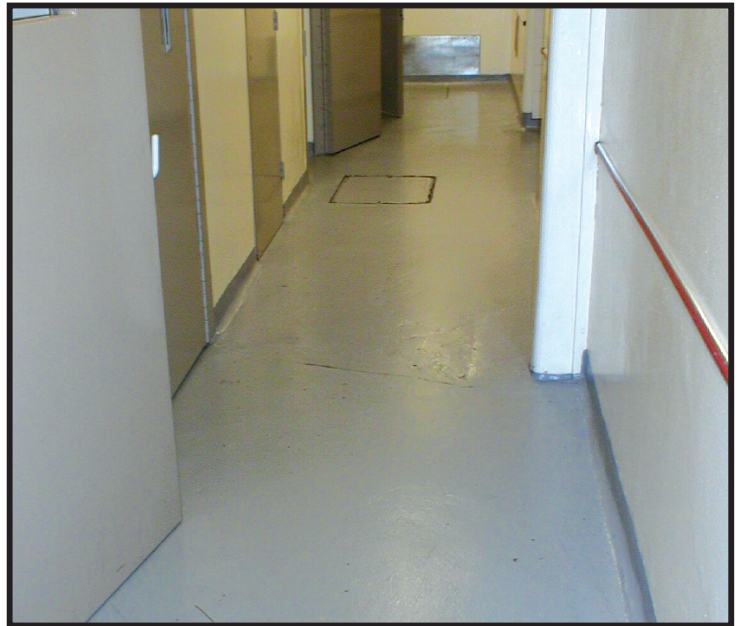
The previously coated corridor floor had become dangerous. Shards of the product had been broken away and had been used for self-harm during a custody period. The pieces of broken product could also be potentially used as weapons.
