PROJECT PROFILE

PROJECT: Wooden Floor Refurbishment

LOCATION: United Kingdom

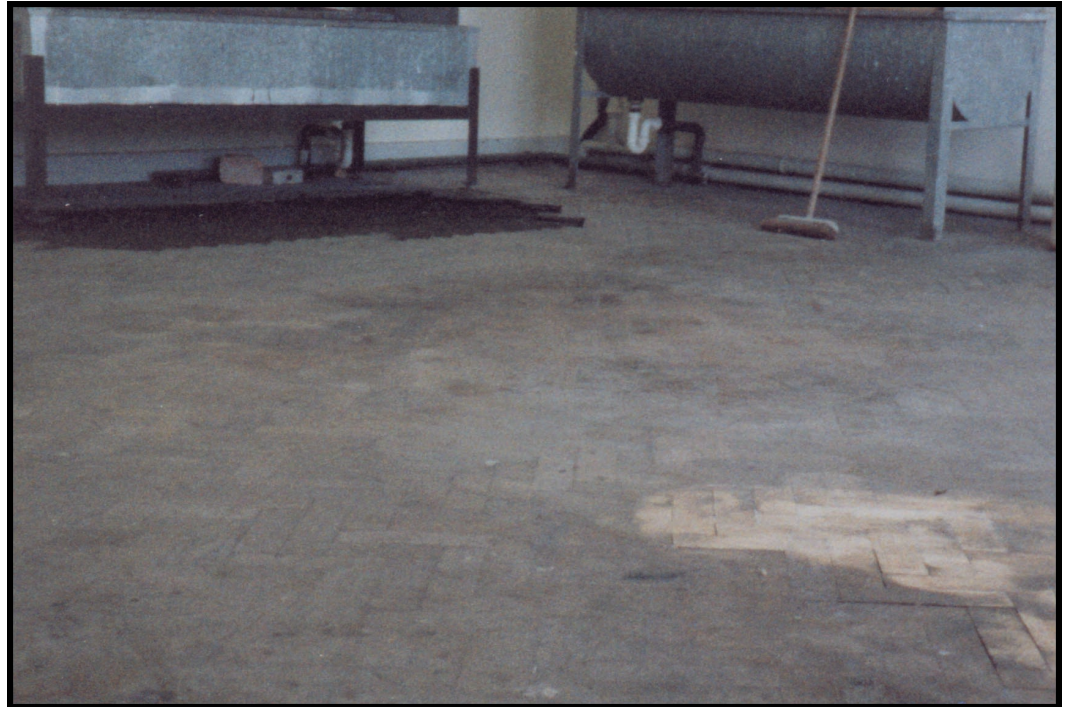
The floor in this room houses a water wash spray booth. Constant splashing from the booth resulted in the wood blocks around the booth being permanently wet, causing them to become loose and eventually lift.

The rest of the floor was extremely dirty and in need of upgrading.
