## PROJECT PROFILE

**PROJECT:** Senica Dairy Cheese Production Area  
– Hygienic Wall Protection

**LOCATION:** Slovak Republic

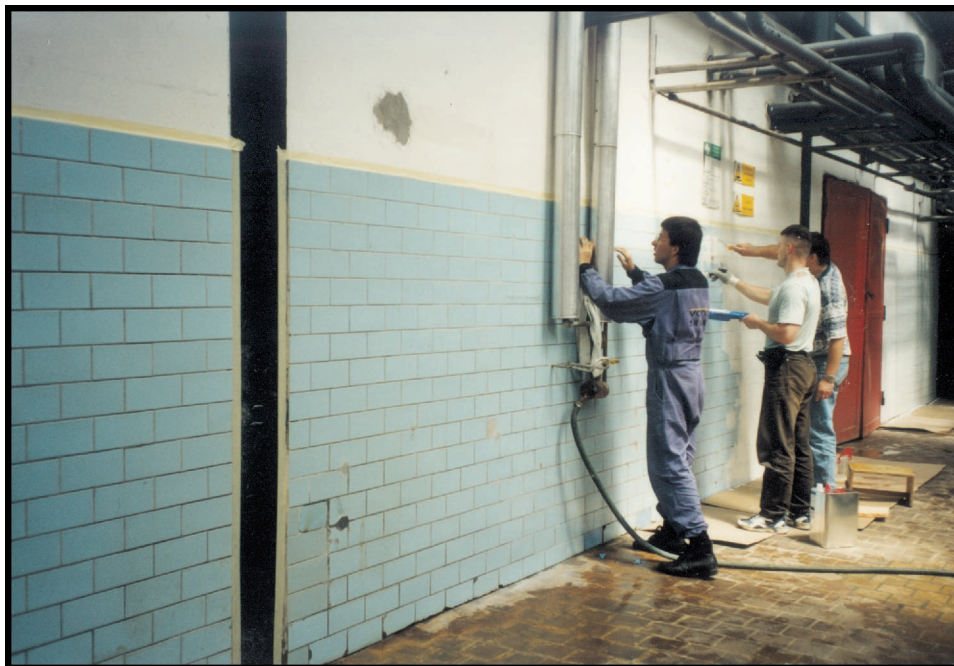
The old tiled walls of this cheese production area at the Senica Dairy were showing signs of localised damaged and the grouting between the tiles was harbouring mould and bacterial growth.

Immediate refurbishment of the production area walls was necessary in order to meet strict environmental health regulations. This necessitated using a high performance hygienic, easy-to-clean wall coating.
