PROJECT PROFILE

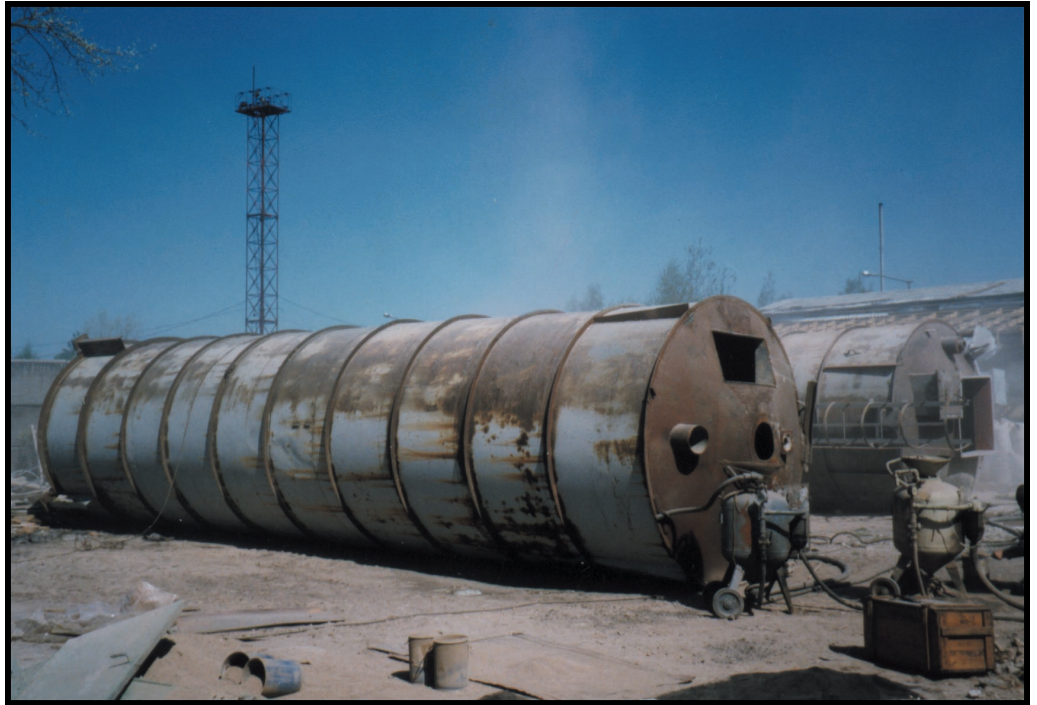
Bulk storage tanks operated by the company, Rudas Latvia, were severely damaged by corrosion.

The corrosion was so bad that the actual structural integrity of the tanks was threatened and immediate repairs were required to prolong the service life of the tanks in question.
