## PROJECT PROFILE

**PROJECT:** MoD 747 Training Rig Refurbishment  
**LOCATION:** United Kingdom

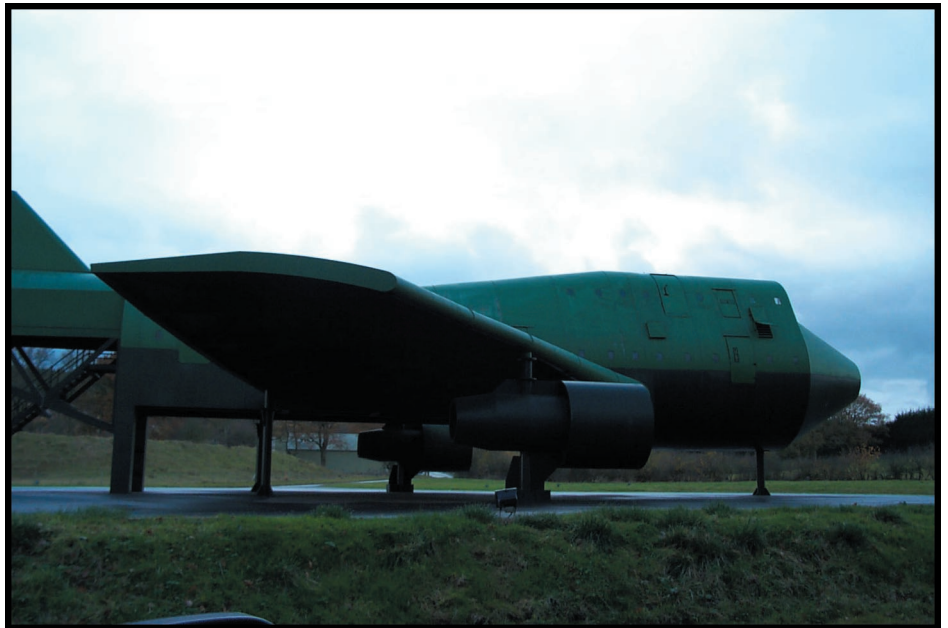
The photograph shows a 747 Training Rig at a Ministry of Defence (MoD) establishment. The rig represents the physical dimensions of a Boeing 747 aircraft and is used to train Special Forces.

The client was looking to upgrade the paint/coating system, which had been applied to the 3,600m<sup>2</sup> steel structure over 12 years ago and was now showing signs of colour deterioration and rusting.
