PROJECT PROFILE

PROJECT: Eccleshill Sports Centre - Roof Refurbishment
LOCATION: United Kingdom

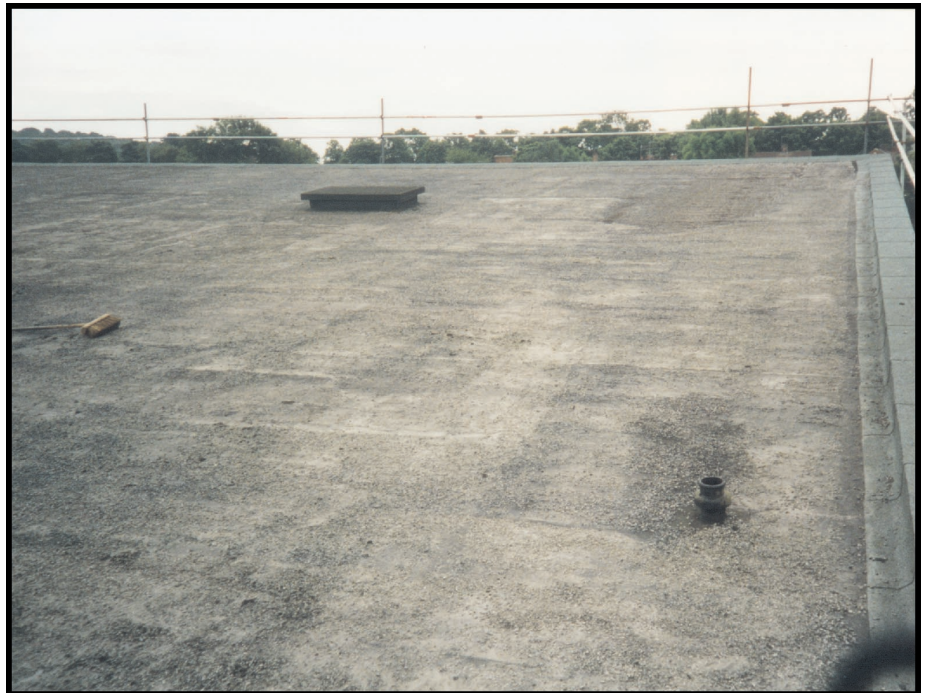
The roof of the Eccleshill Sports Centre owned by Bradford Borough Council had deteriorated over time and was in need of refurbishment.
