PROJECT PROFILE

PROJECT: Southgate House - Roof Refurbishment
LOCATION: United Kingdom

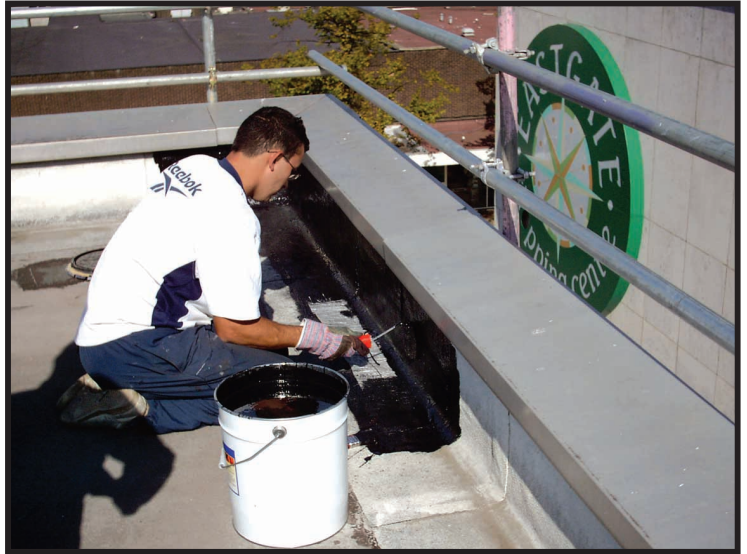
This town centre office complex located in Basildon, Essex had several roof areas totalling 6,000m². These consisted mainly of asphalt but with some areas of other old and degraded roofing materials. Over the years, the roof had been fitted with air conditioning units and other plant. The roof was in need of refurbishment to prevent roof failure as well as damage to the offices and equipment below.
