## PROJECT PROFILE

**PROJECT:** Roof Repairs

**LOCATION:** Portugal

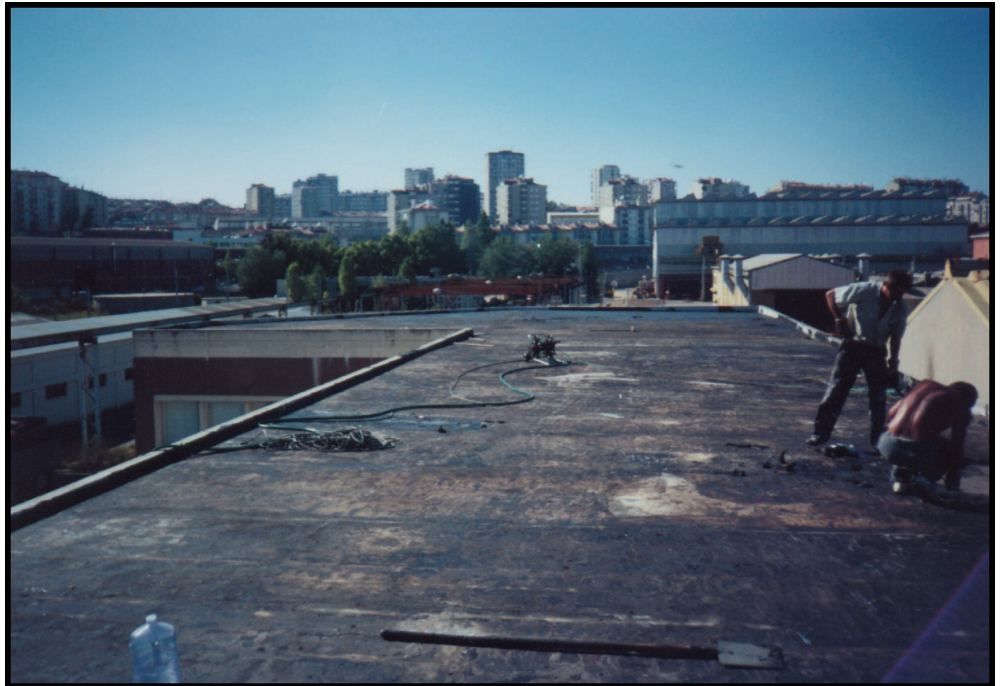
This flat roof was suffering major problems from water penetration and the structure of the roof had deteriorated to a point where total refurbishment was required.

After discussions with the owners, Sorefane, who are a subsidiary of ABB, it was agreed that a complete refurbishment would be carried out using the Poly-Tech system.
