PROJECT PROFILE

PROJECT: Food Industry
LOCATION: Barcelona—Spain

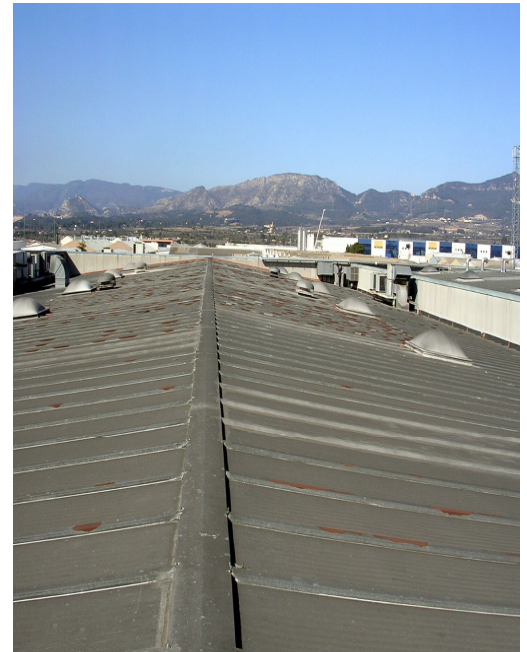
This picture was taken at a Food Factory in Barcelona Spain.

This metallic roof of 4200 square meters needed to be repaired, having suffered from severe leaks.
