PROJECT PROFILE

PROJECT: Institute of Higher Education - Workshop Floor Refurbishment
LOCATION: United Kingdom

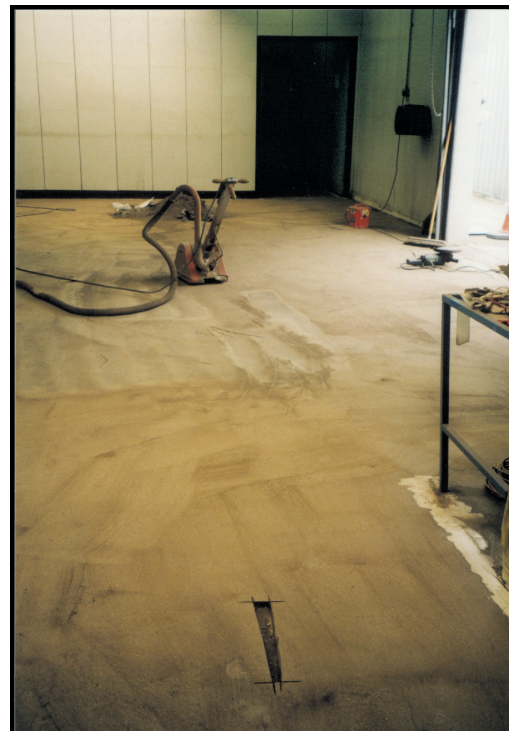
The previously coated asphalt floor had degraded over time and showed signs of severe localised damage.

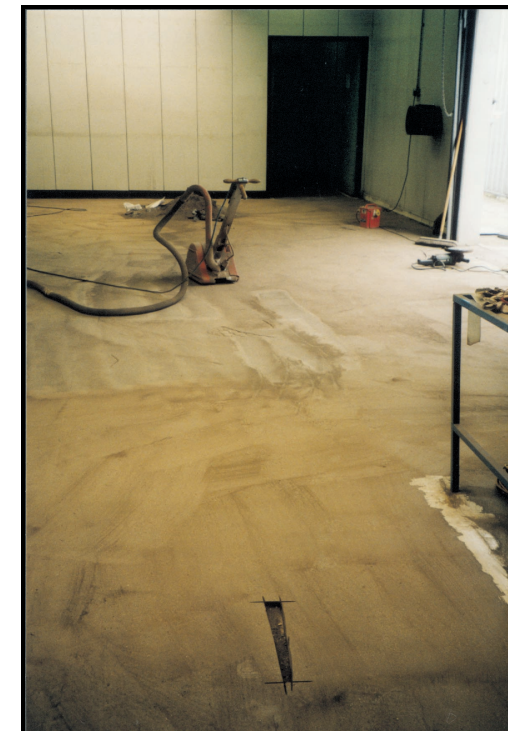
The previously coated asphalt floor had degraded over time and showed signs of severe localised damage.
