PROJECT PROFILE

PROJECT: Swimming Pool Ductwork

LOCATION: United Kingdom

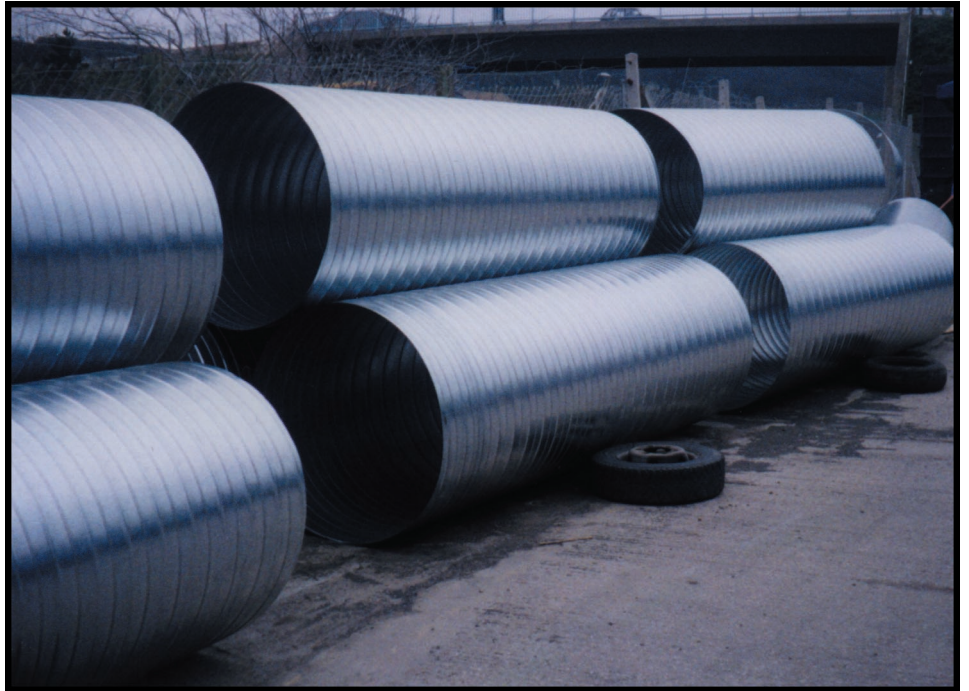
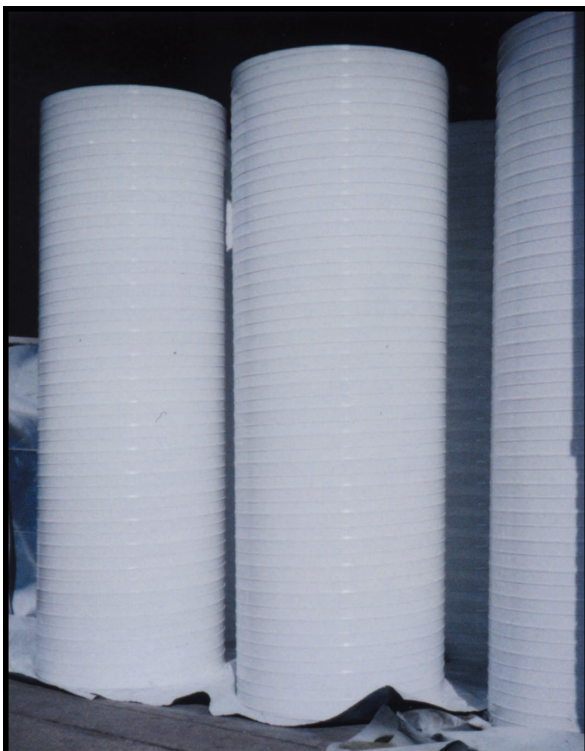
A suitable finish was required for the protection of galvanised ductwork.

The selected finish had to withstand attack from high humidity and chlorine internally and be aesthetically pleasing externally.

Both internal and external surfaces received one coat of Corro-tech AP Primer, followed by one stripe coat of Uni-tech UV and one overall coat of Uni-Tech UV.

This system has met all of the clients requirements and they are delighted with the quality of the finish achieved.
